GREENSBURG LOG HOME

Description:

THE DISMANTLEMENT PROCESS

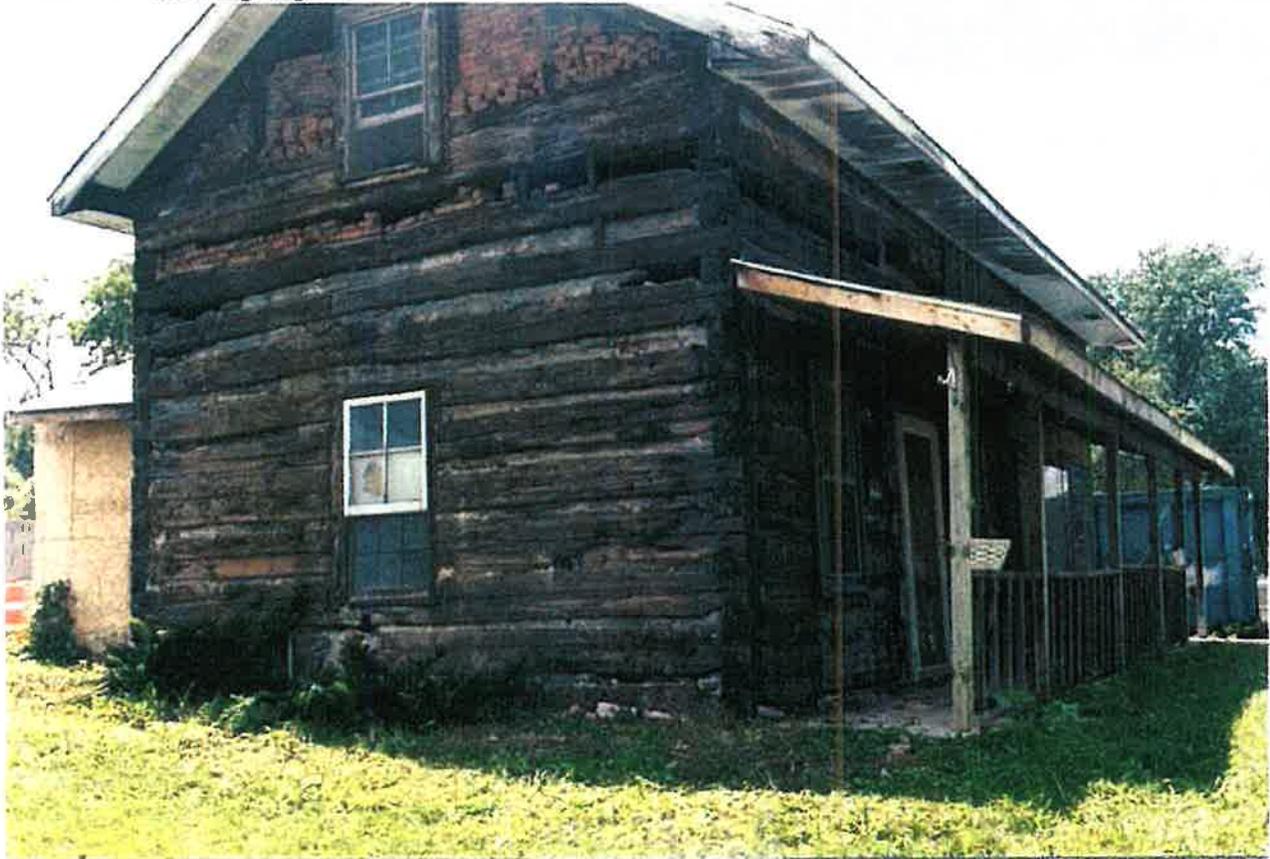
▼ Side view showing large timbers and brick filling.

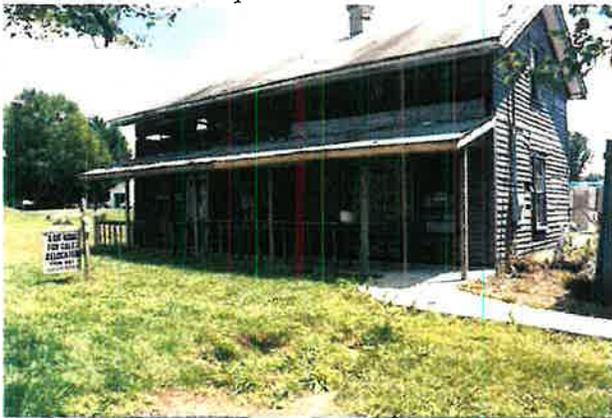
▼ Log home is on left. An addition is on the right is still covered by siding. One of the most interesting features of the addition was the use of transitional framing techniques -a combination of traditional braced timber frame with the more modern balloon framing. This kind of construction, called “brace timber frame”, appears in the addition as 4” x 4” corner posts and 4” x 4” diagonal braces which were used in addition to 2” x 4” studs. This method was used from the early 1840’s through the 1880’s. This addition is a late variation of that construction technique.

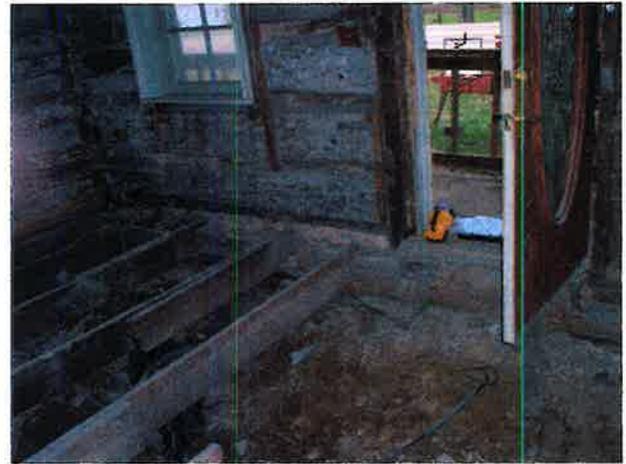
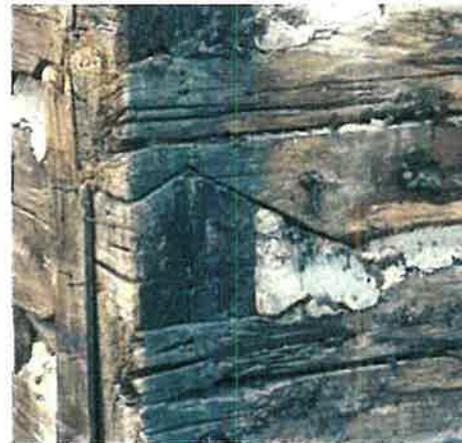
▼ At some time, the original log floor joists were replaced by the more modern 2” thick joists.

▲ The joints are a form of dovetail joint called “steeple notch”. Since the joints in the lower floor are quite tight, but the second floor joints had wedges placed between the log courses, it is likely that the log home was originally built as a one-story home and was later converted to one and a half stories. The irregular spacing between the courses is evidence that the home pre-dates the time when professional log homebuilders came into the territory. It is likely that this log home was built between 1810 and 1820.

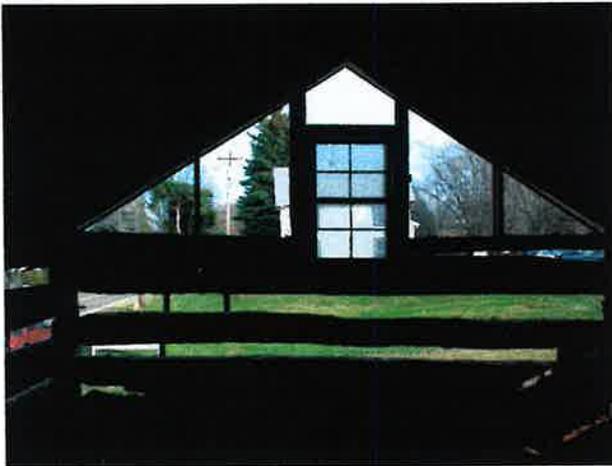
▼ The dismantlement process started with the careful tagging of each member and drawing of the existing structure. Then the brick fill and the chinking between the log courses was removed.

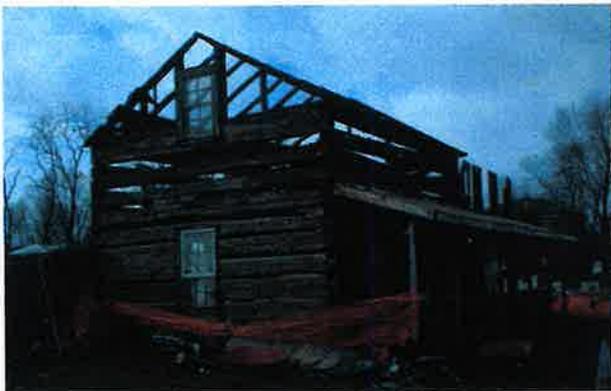
▼ The roof shingles and roof planks were removed next, then the braced timber frame addition was dismantled.

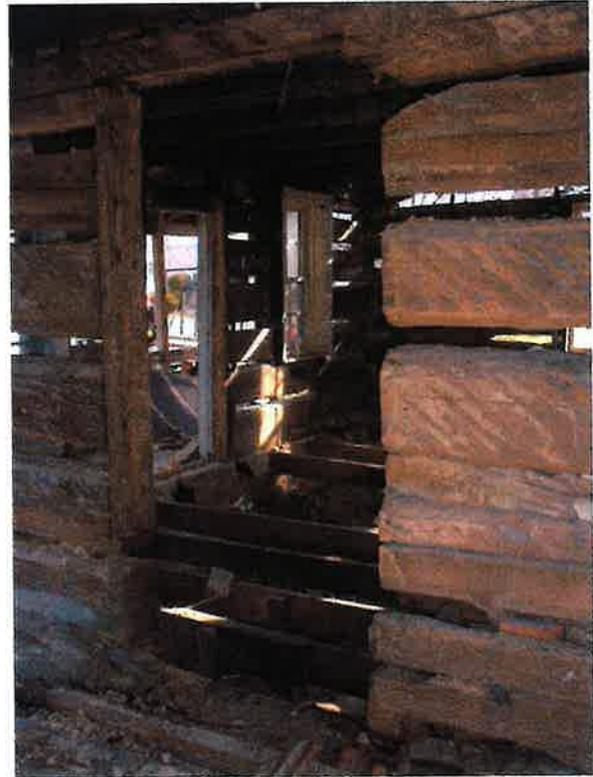
▼ View through the side door. Note the pegs in the doorframe.

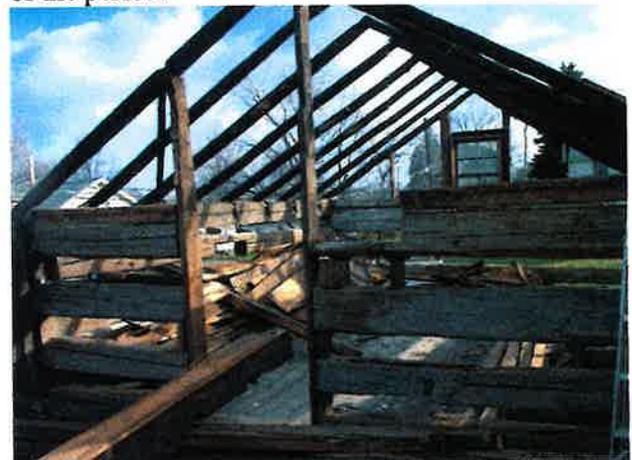
▼ At this point in the dismantlement process, the crew was surprised to discover roman numerals carved into each roof rafter. They were barely visible and only became apparent once the roof planks were off. The use of roman numerals was a common marking technique used by homebuilders of the period.

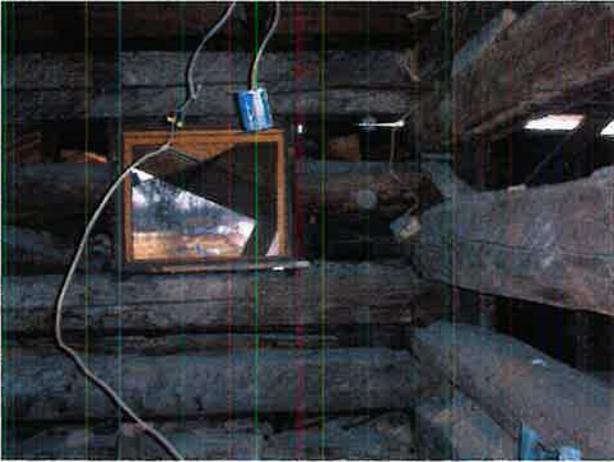
▼ This is the stairwell area. Note the wedges between the log courses. Also note the notches cut in the roof plate. This indicates a likelihood that the roof plate was re-used from earlier construction – most likely it was the original roof over the first floor.

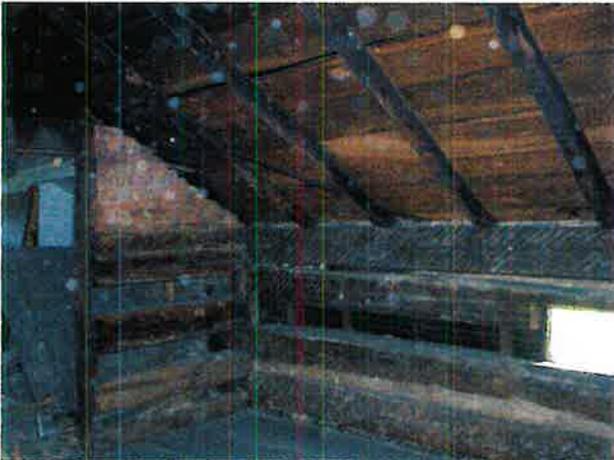
▼ The rafters consist of logs hewn on only one side. The wide roof planks were characteristic of early and mid 1800's construction. The original doorframe shown here was pegged as were the window and doorframes throughout the log home. This construction was also typical of early and mid 1800's construction.

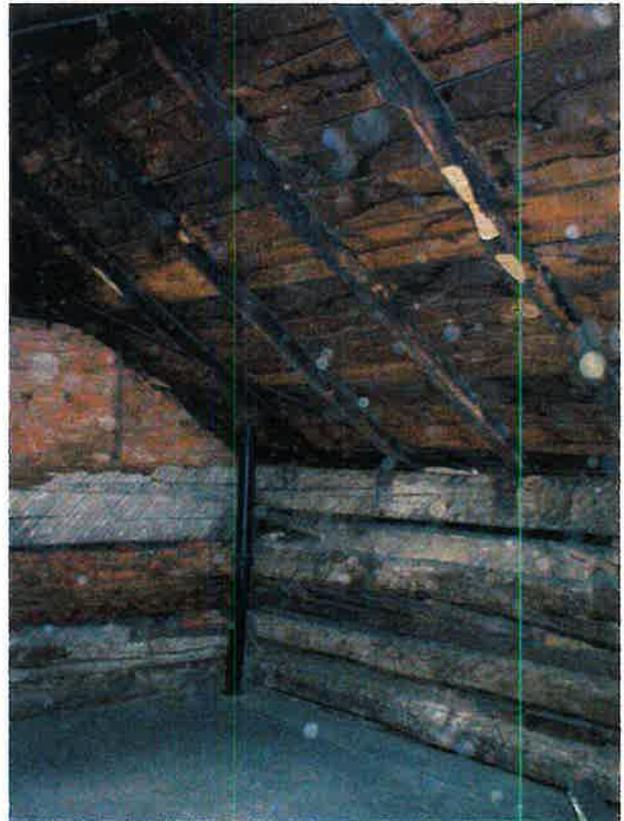
▼ The left rear corner of the log home, showing the brick fill and roof structure.

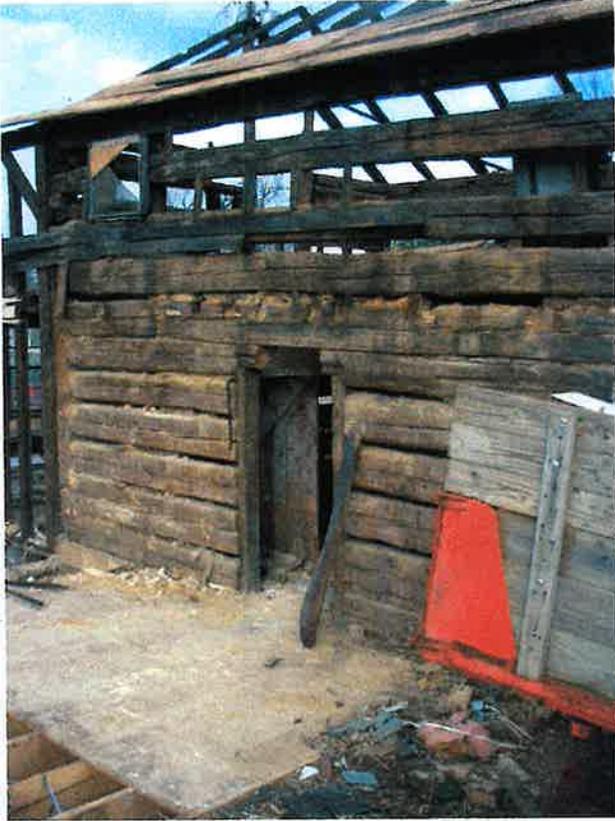
▼ This view of the back shows how the top of the doorway was cut out.

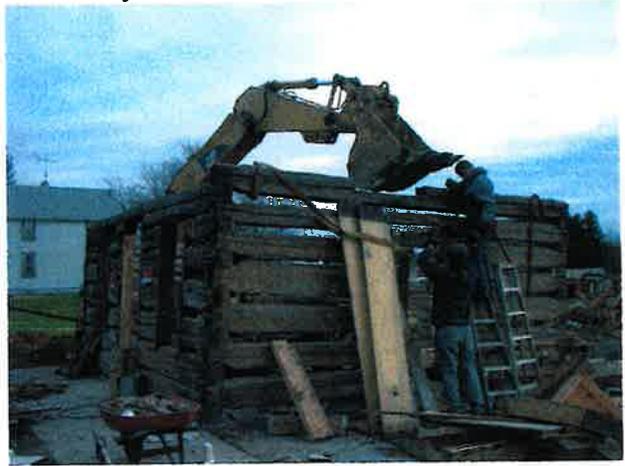
▼ Straps were tied to the ends of the logs and they were chained in the middle and lapped over the teeth of the crane's bucket. Using this method, they were easily lifted onto the trailer.

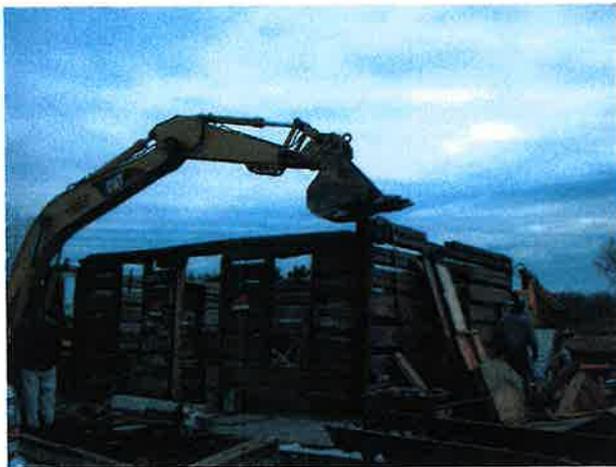
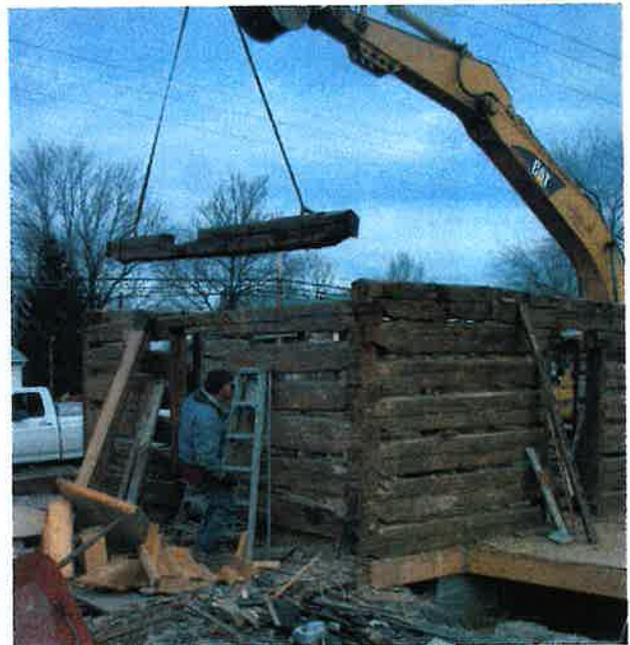
▼ A crane was needed to remove the top courses of logs. The logs that had cutouts for the windows were strengthened by nailing 2"x 6" planks along their length to prevent the logs from breaking apart.

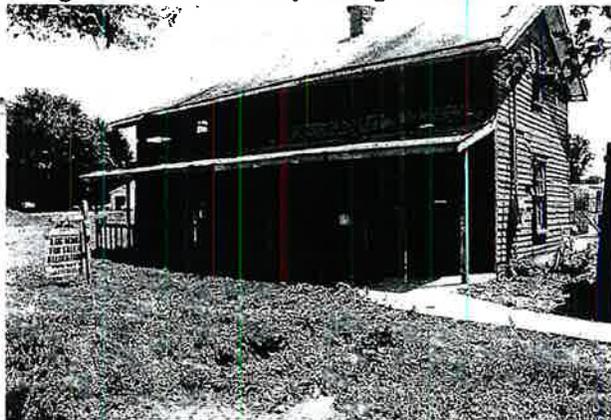
▼ Log home is on left. Post and beam addition is on right and is covered by siding.
